3.0 THE CONSERVATION AREA ENVIRONMENT

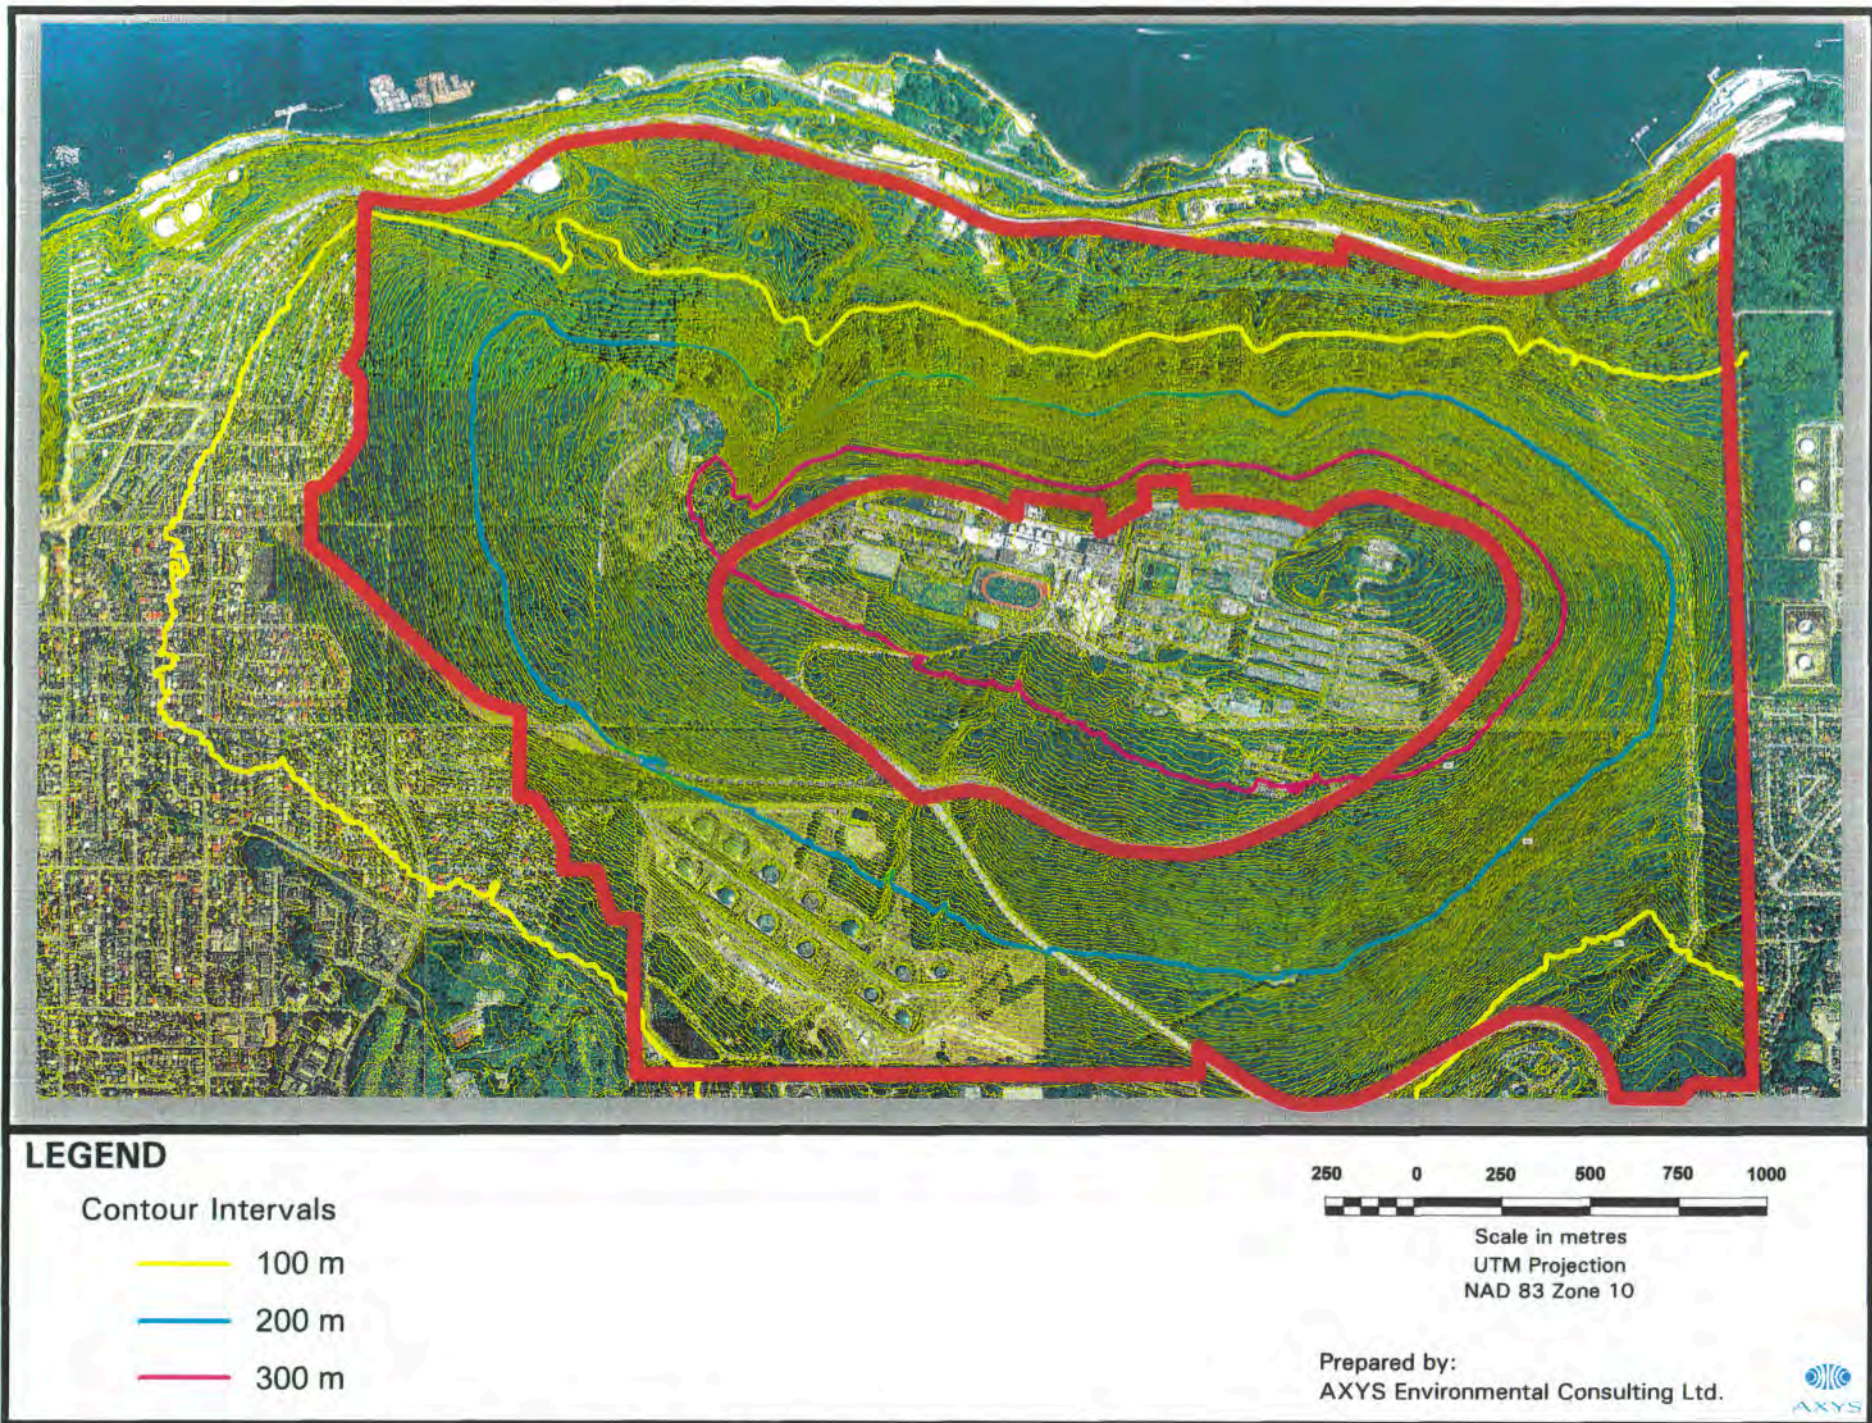
Figure 3-1: Terrain map of the Burnaby Mountain Conservation Area

Burnaby Mountain is the highest point in the City of Burnaby at about 360m (1200 feet) above sea level (Figure 3-1). The mountain is underlain by layers of sandstone, shale, conglomerate and siltstone that together form the Kitsilano and Burrard

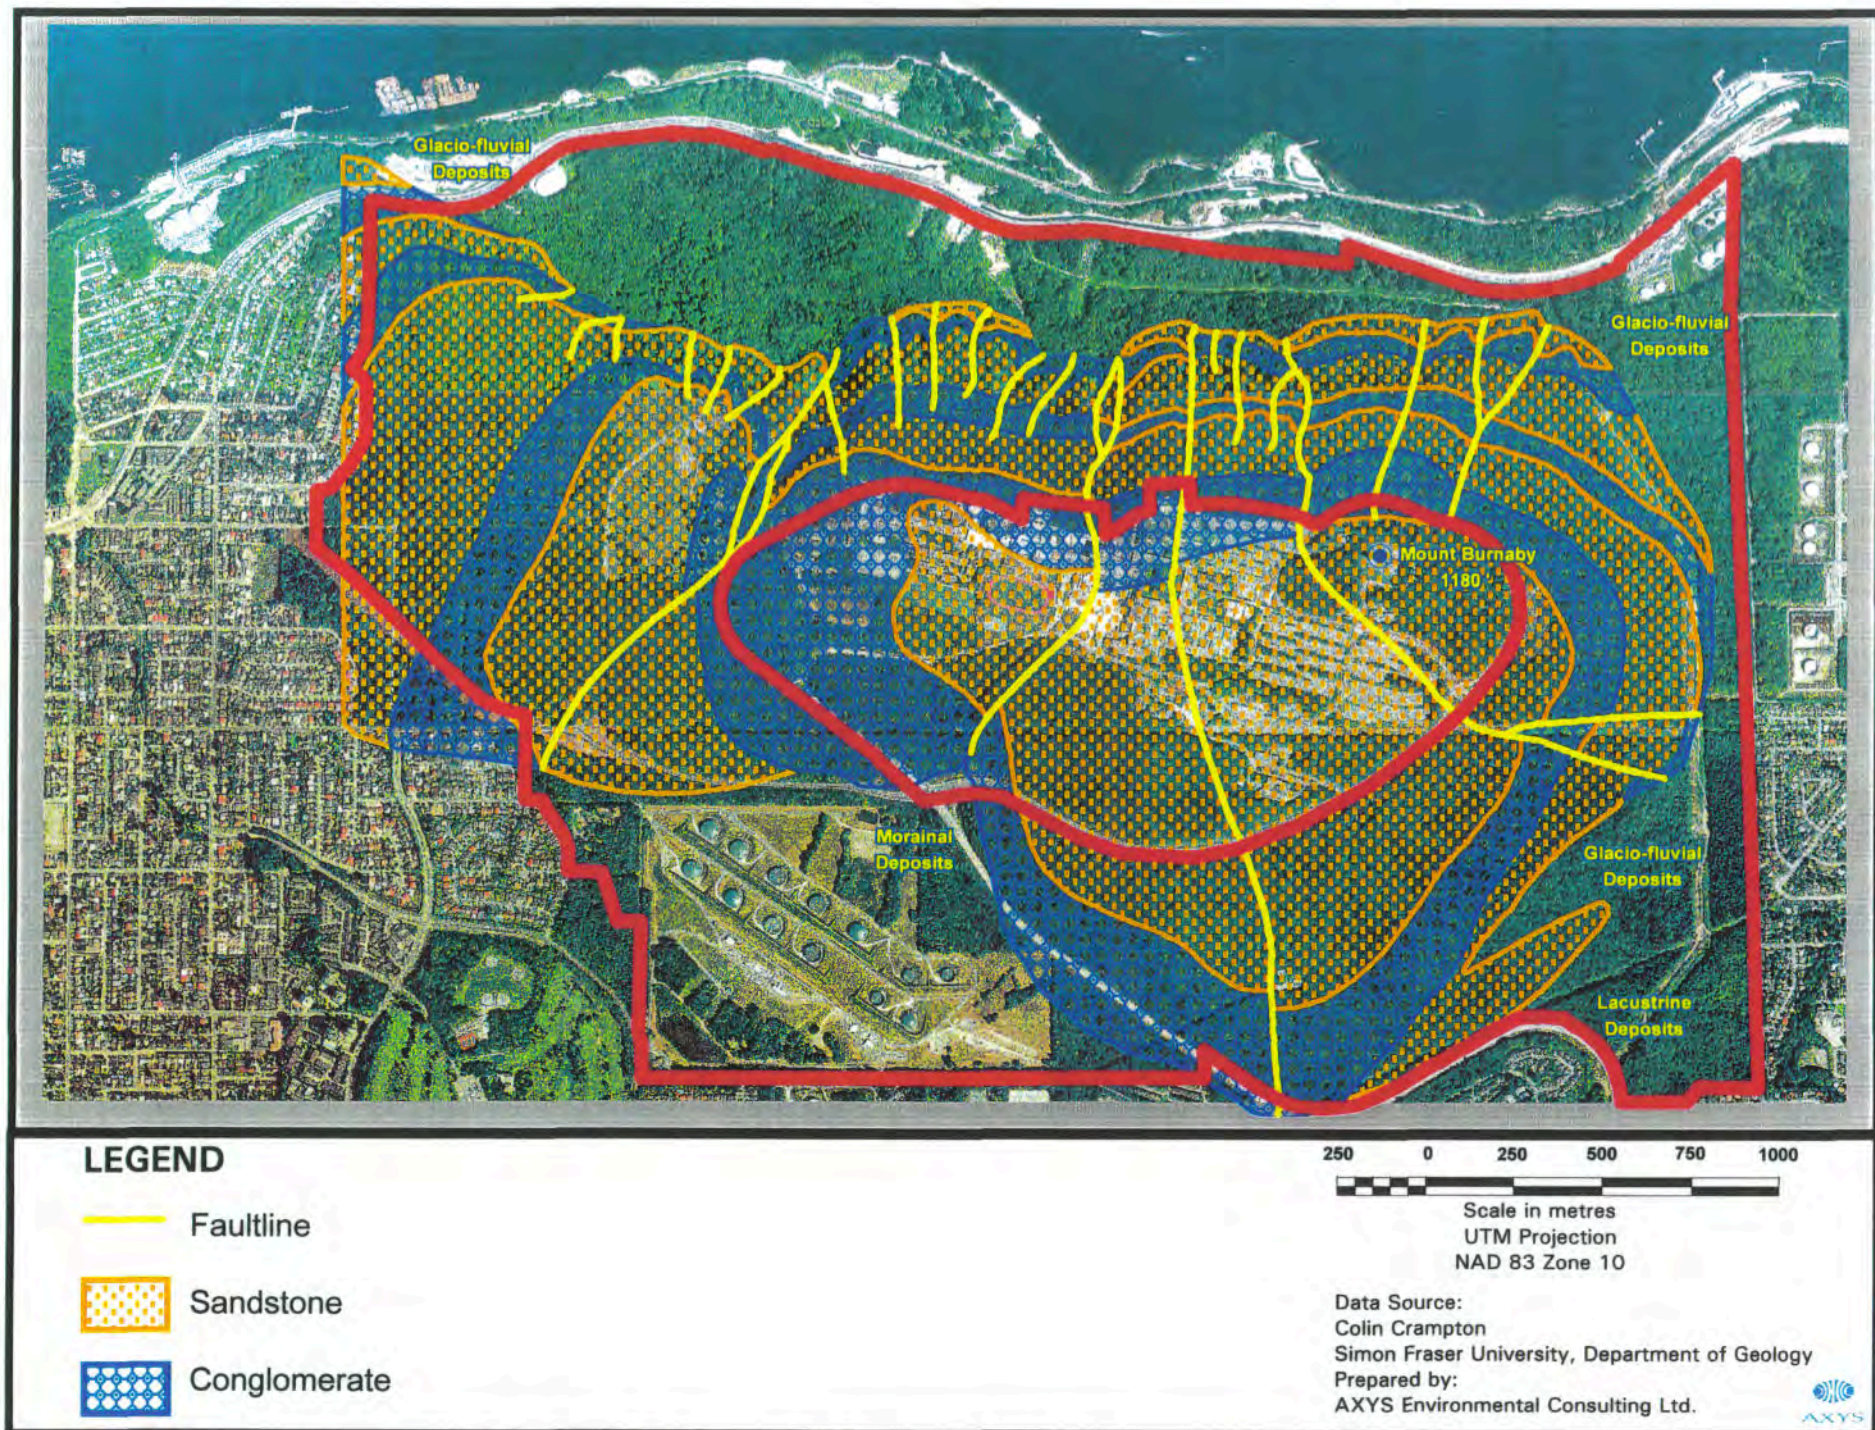
Figure 3-2: Geology of the Burnaby Mountain Conservation Area

Formation (Figure 3-2) (Armstrong 1990, REM 1996). Hard conglomerates cap the mountain and crop out along the middle escarpment to form cliff-sided ravines best seen below Centennial Pavilion. Large boulders or "erratics" which have been deposited by receding glaciers approximately 15,000 years ago can also be found on the mountain.

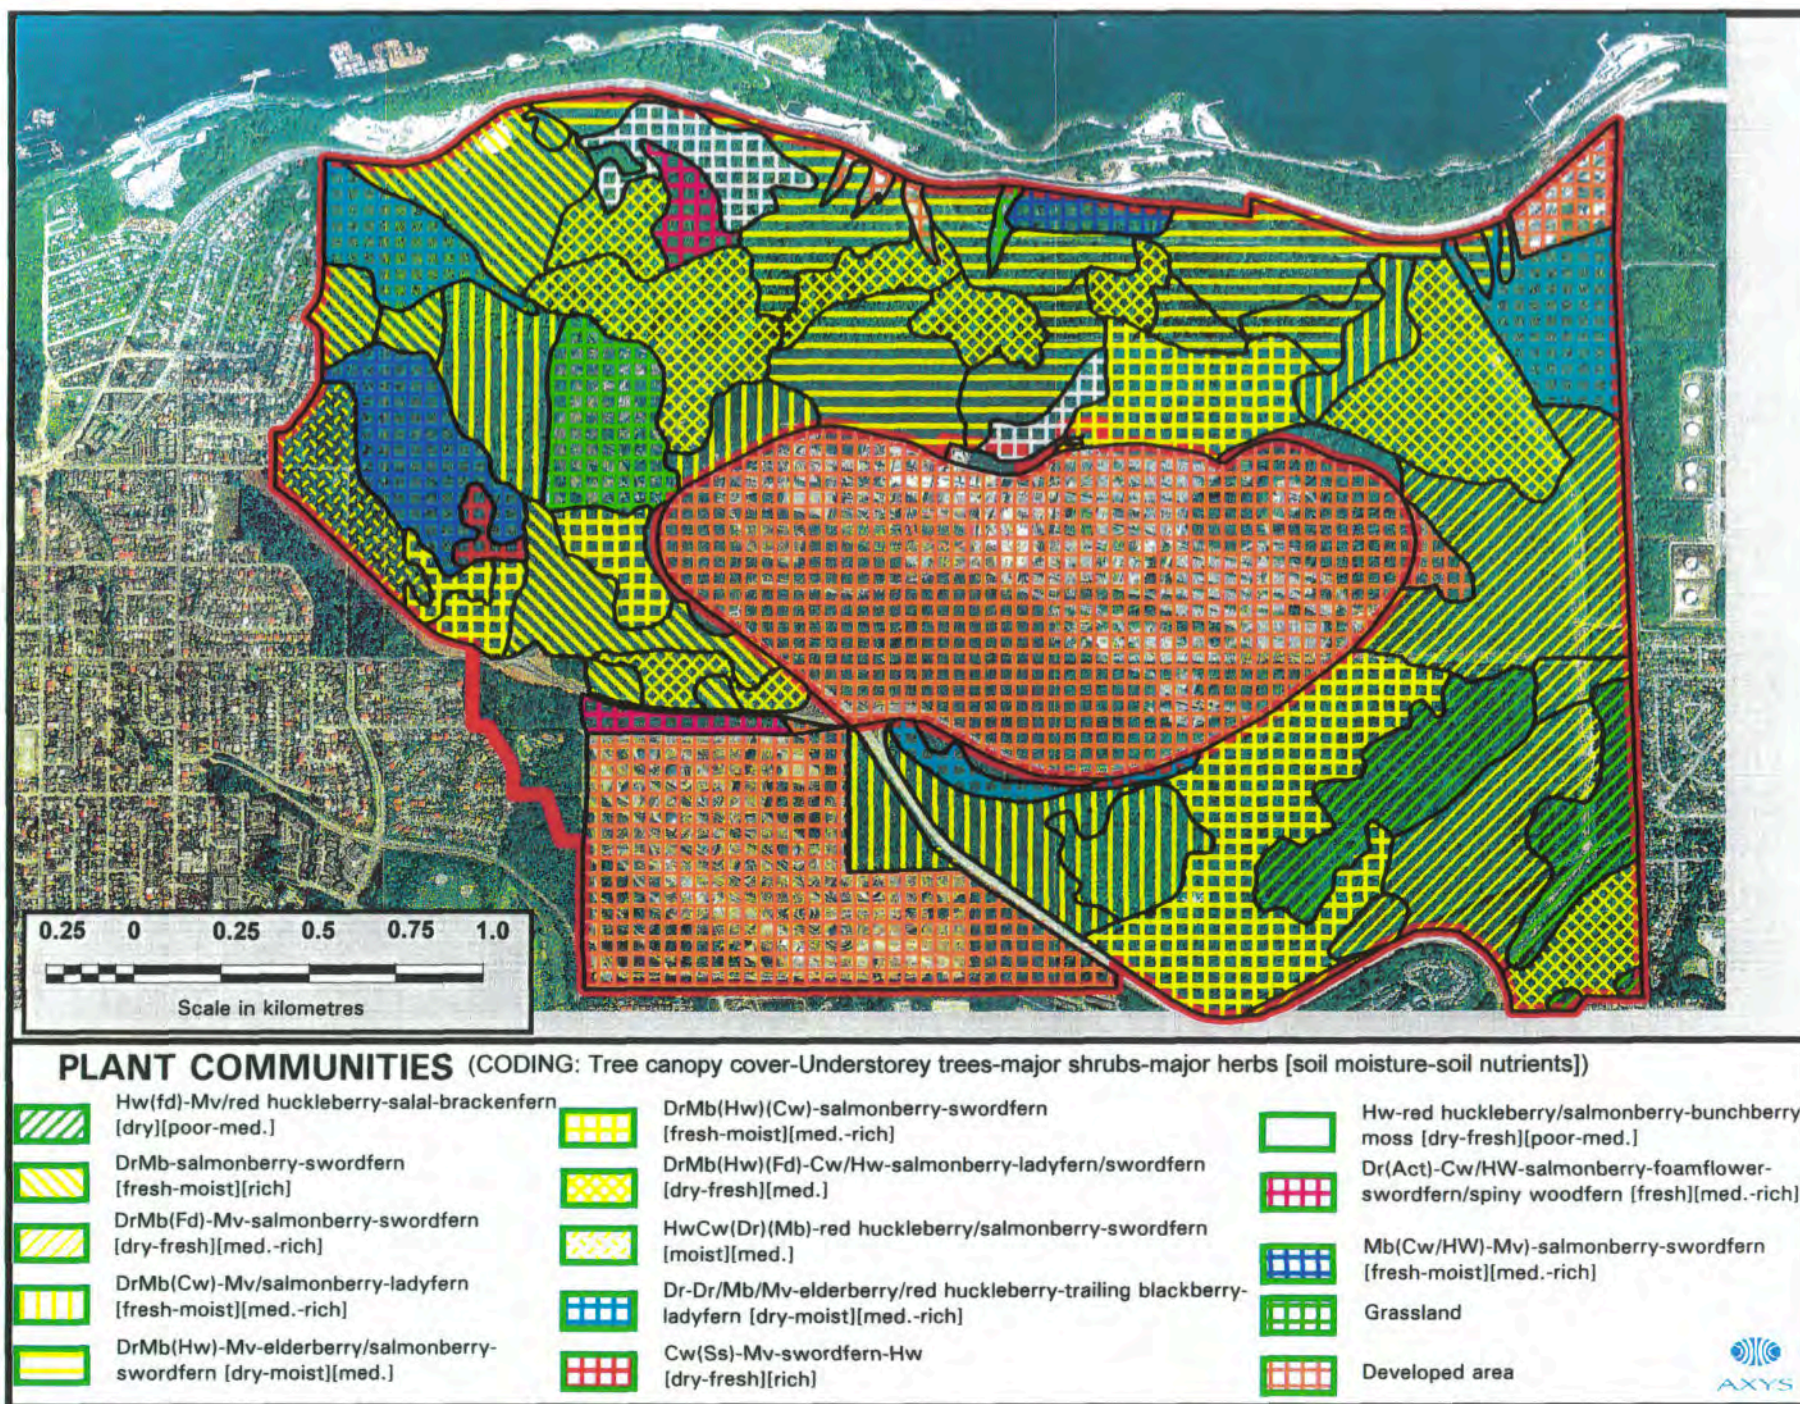
Figure 3-3: Vegetation Communities within the Burnaby Mountain Conservation Area

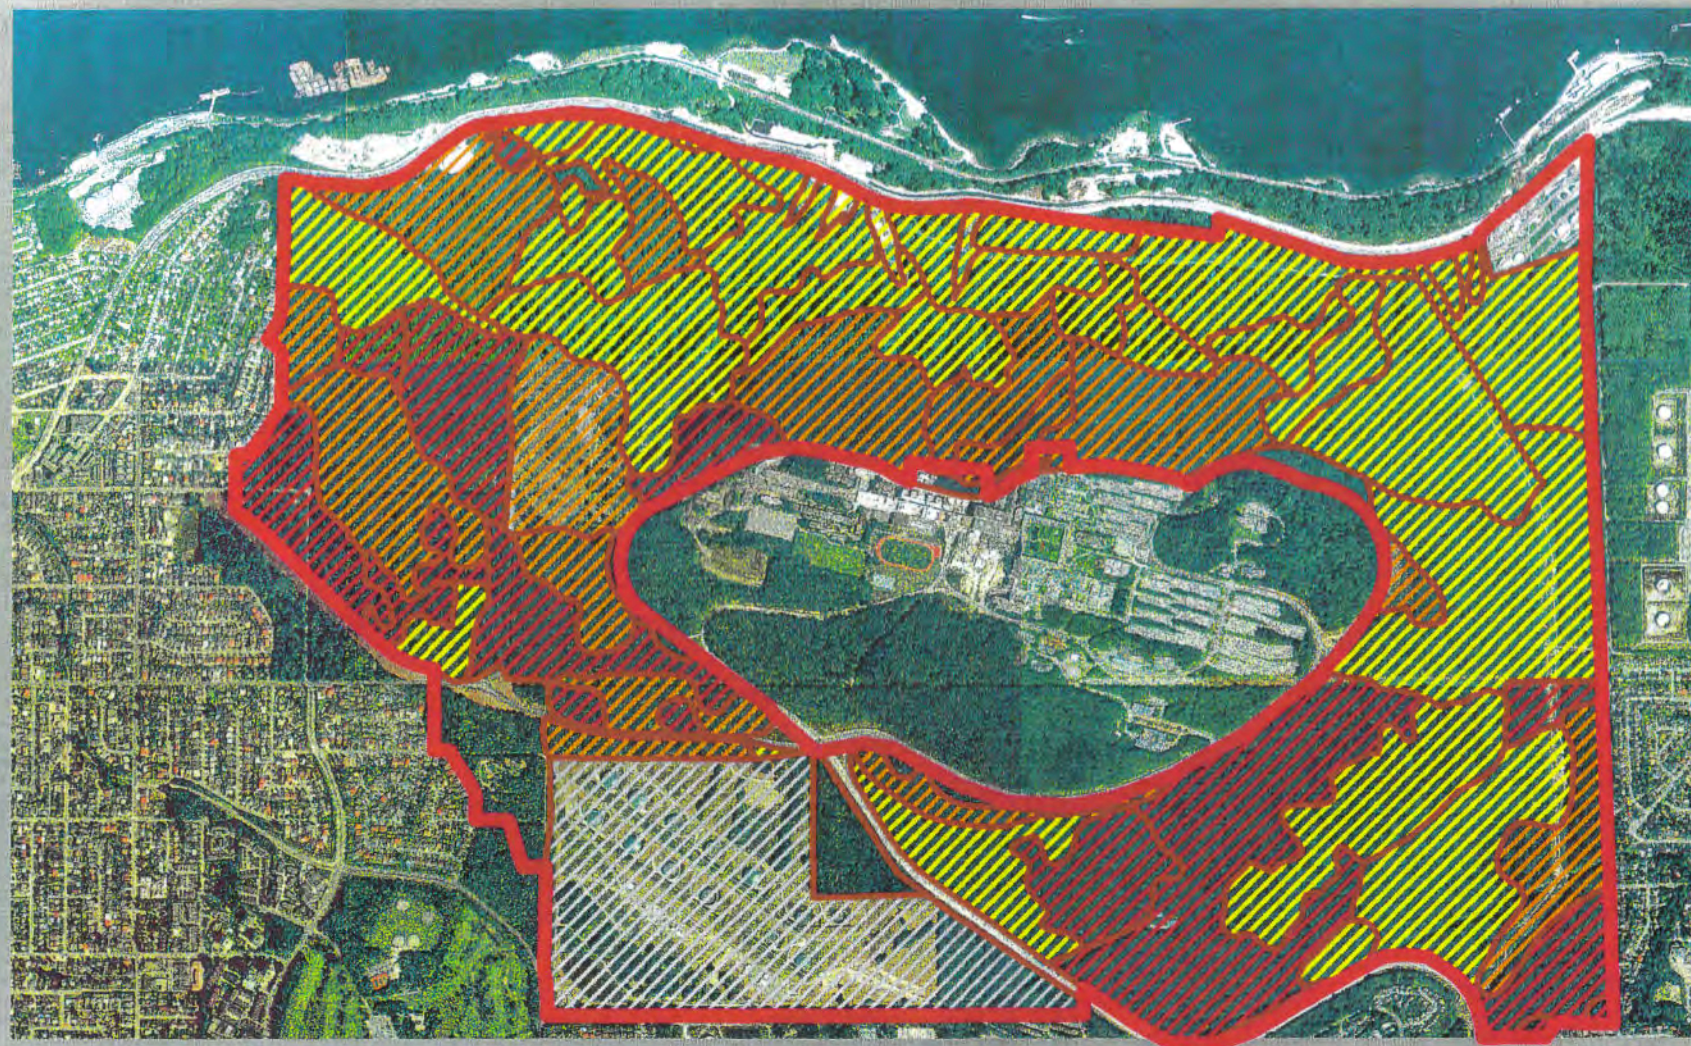
Habitat Suitability Index (0.0 to 1.0)

Three species were selected for more detailed analysis of habitat suitability: bats, black-tailed deer, and pileated woodpecker (See Section 2.2.5 and Appendix D). All three species have been observed on Burnaby Mountain and are expected to reside there either seasonally or year-round. These species were selected to represent a range of tolerances to human disturbance: high for bats; moderate for deer; and low for woodpecker. Maps showing habitat suitability on Burnaby Mountain for these three species are presented in Figures 3-4 through 3-6.

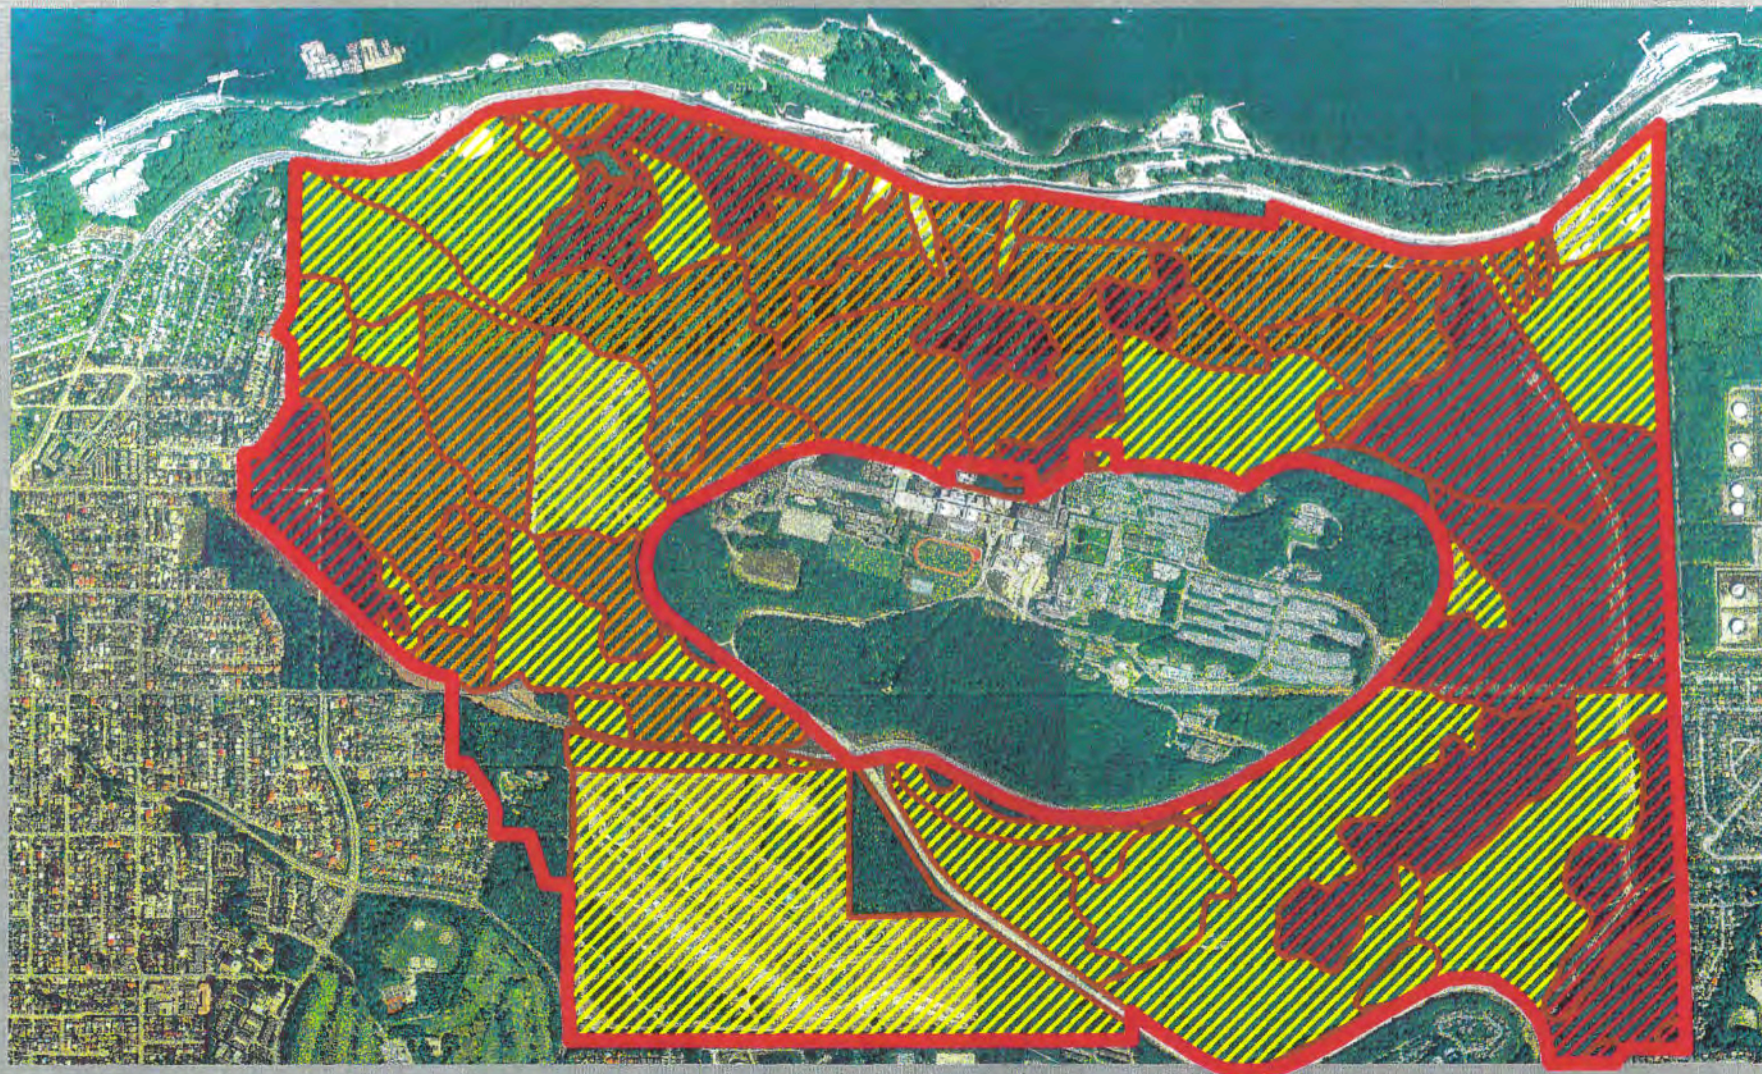
Habitat Suitability

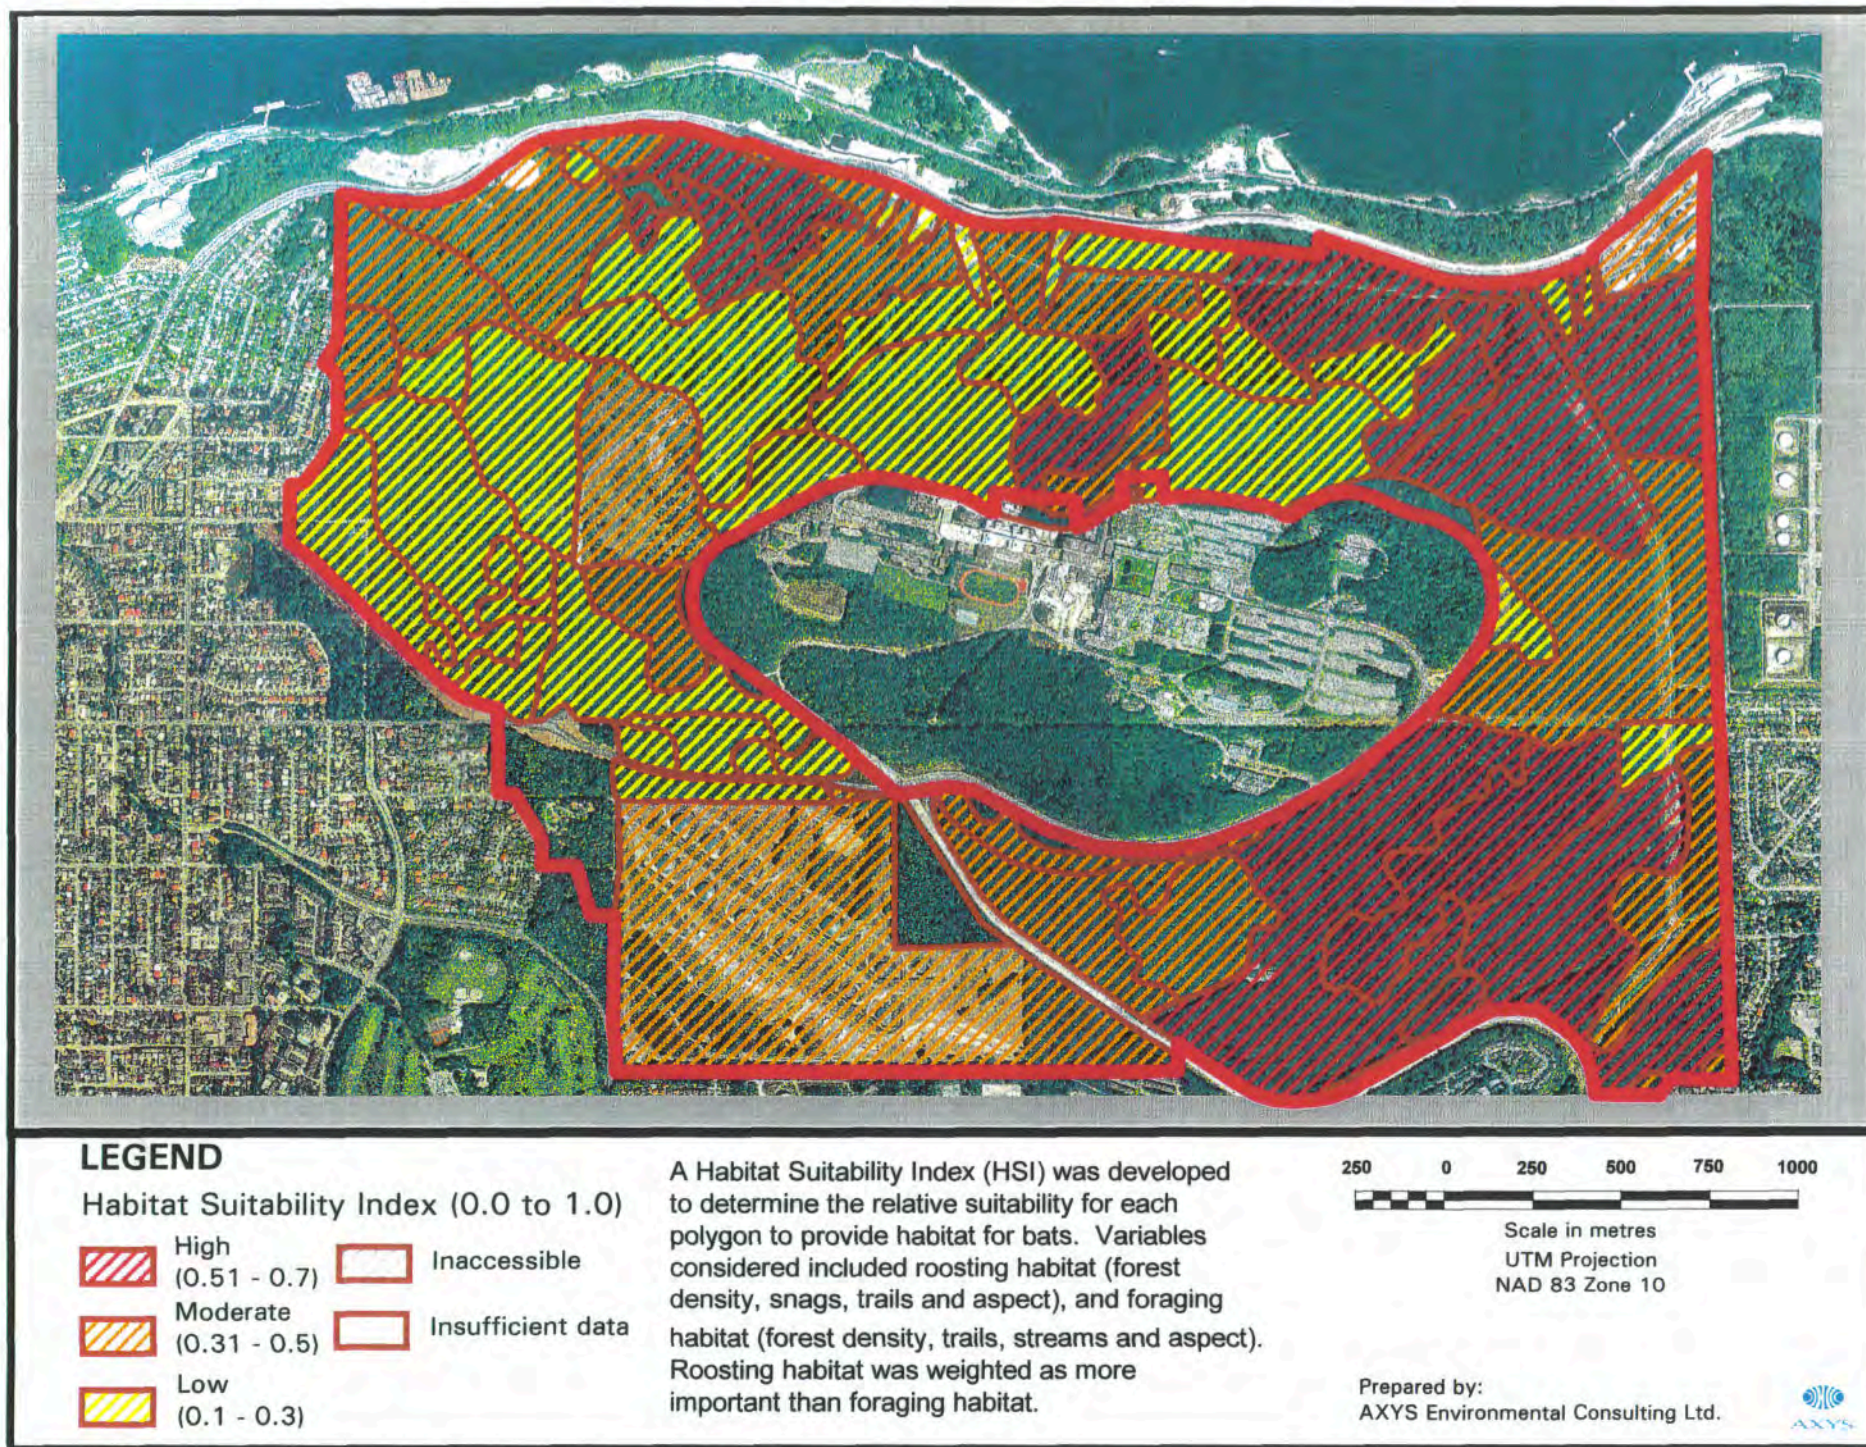
Figure 3-6: Relative Habitat Suitability for Bats

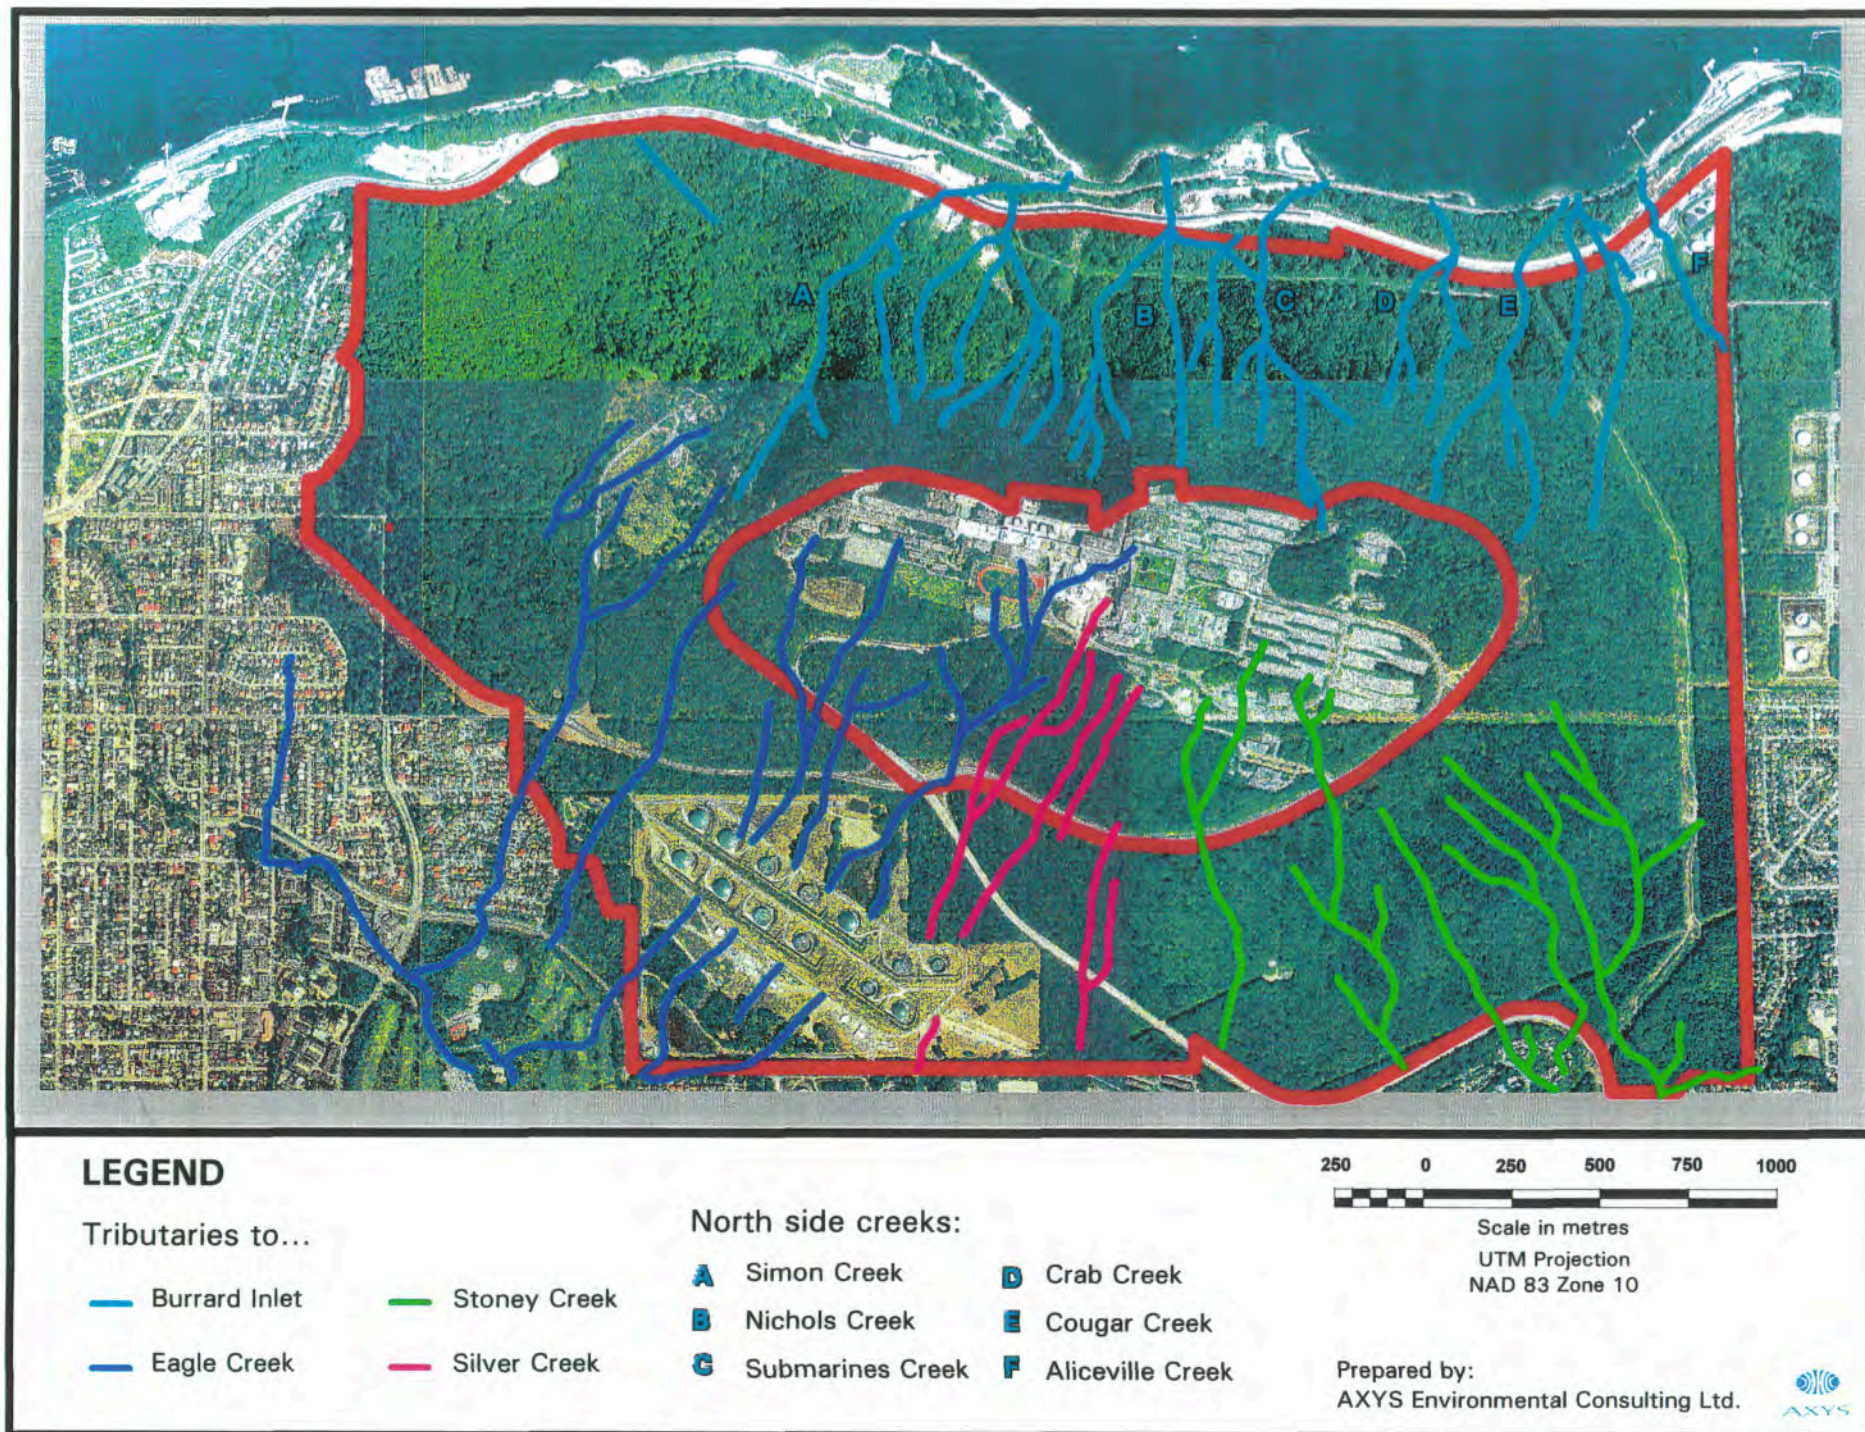
Figure 3-7: Watercourses in the Burnaby Mountain Conservation Area

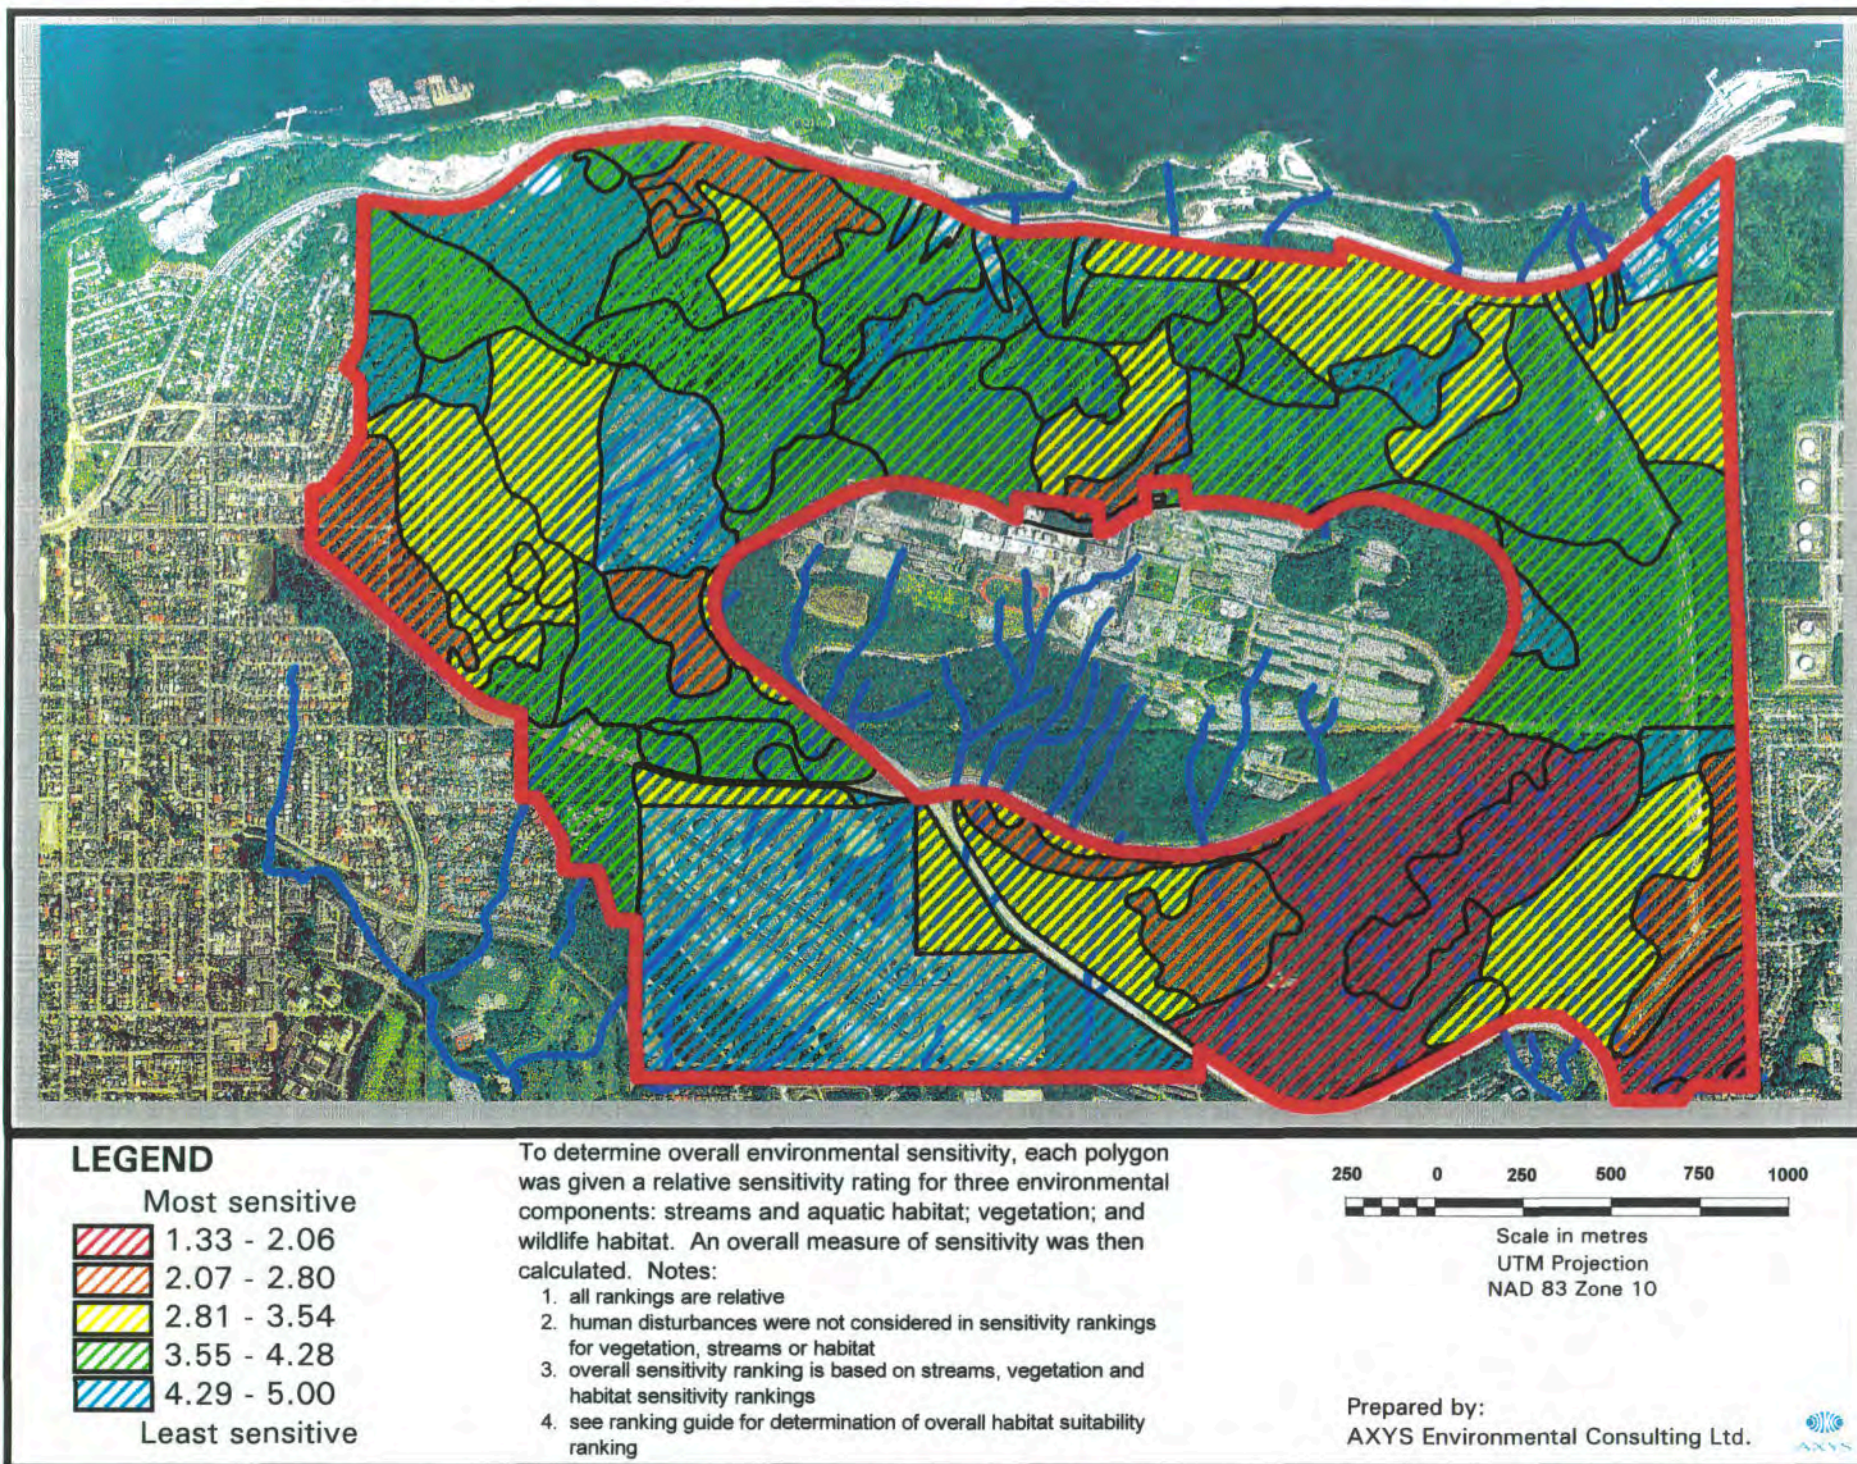
Figure 3-8: Relative Sensitivity based on Vegetation, Watercourses and Wildlife Habitat

Based on this assessment, three areas of the conservation area were rated as most significant in terms of VHW criteria (Class 1 and 2). A large block of significant habitat was identified on the south slope of the mountain (Figure 3-8). This was the only part of the conservation area that received a Class 1 rating (the most significant). The high rating here was mainly attributed to the presence of fish-bearing watercourses and to the moderate to high habitat ratings for the selected

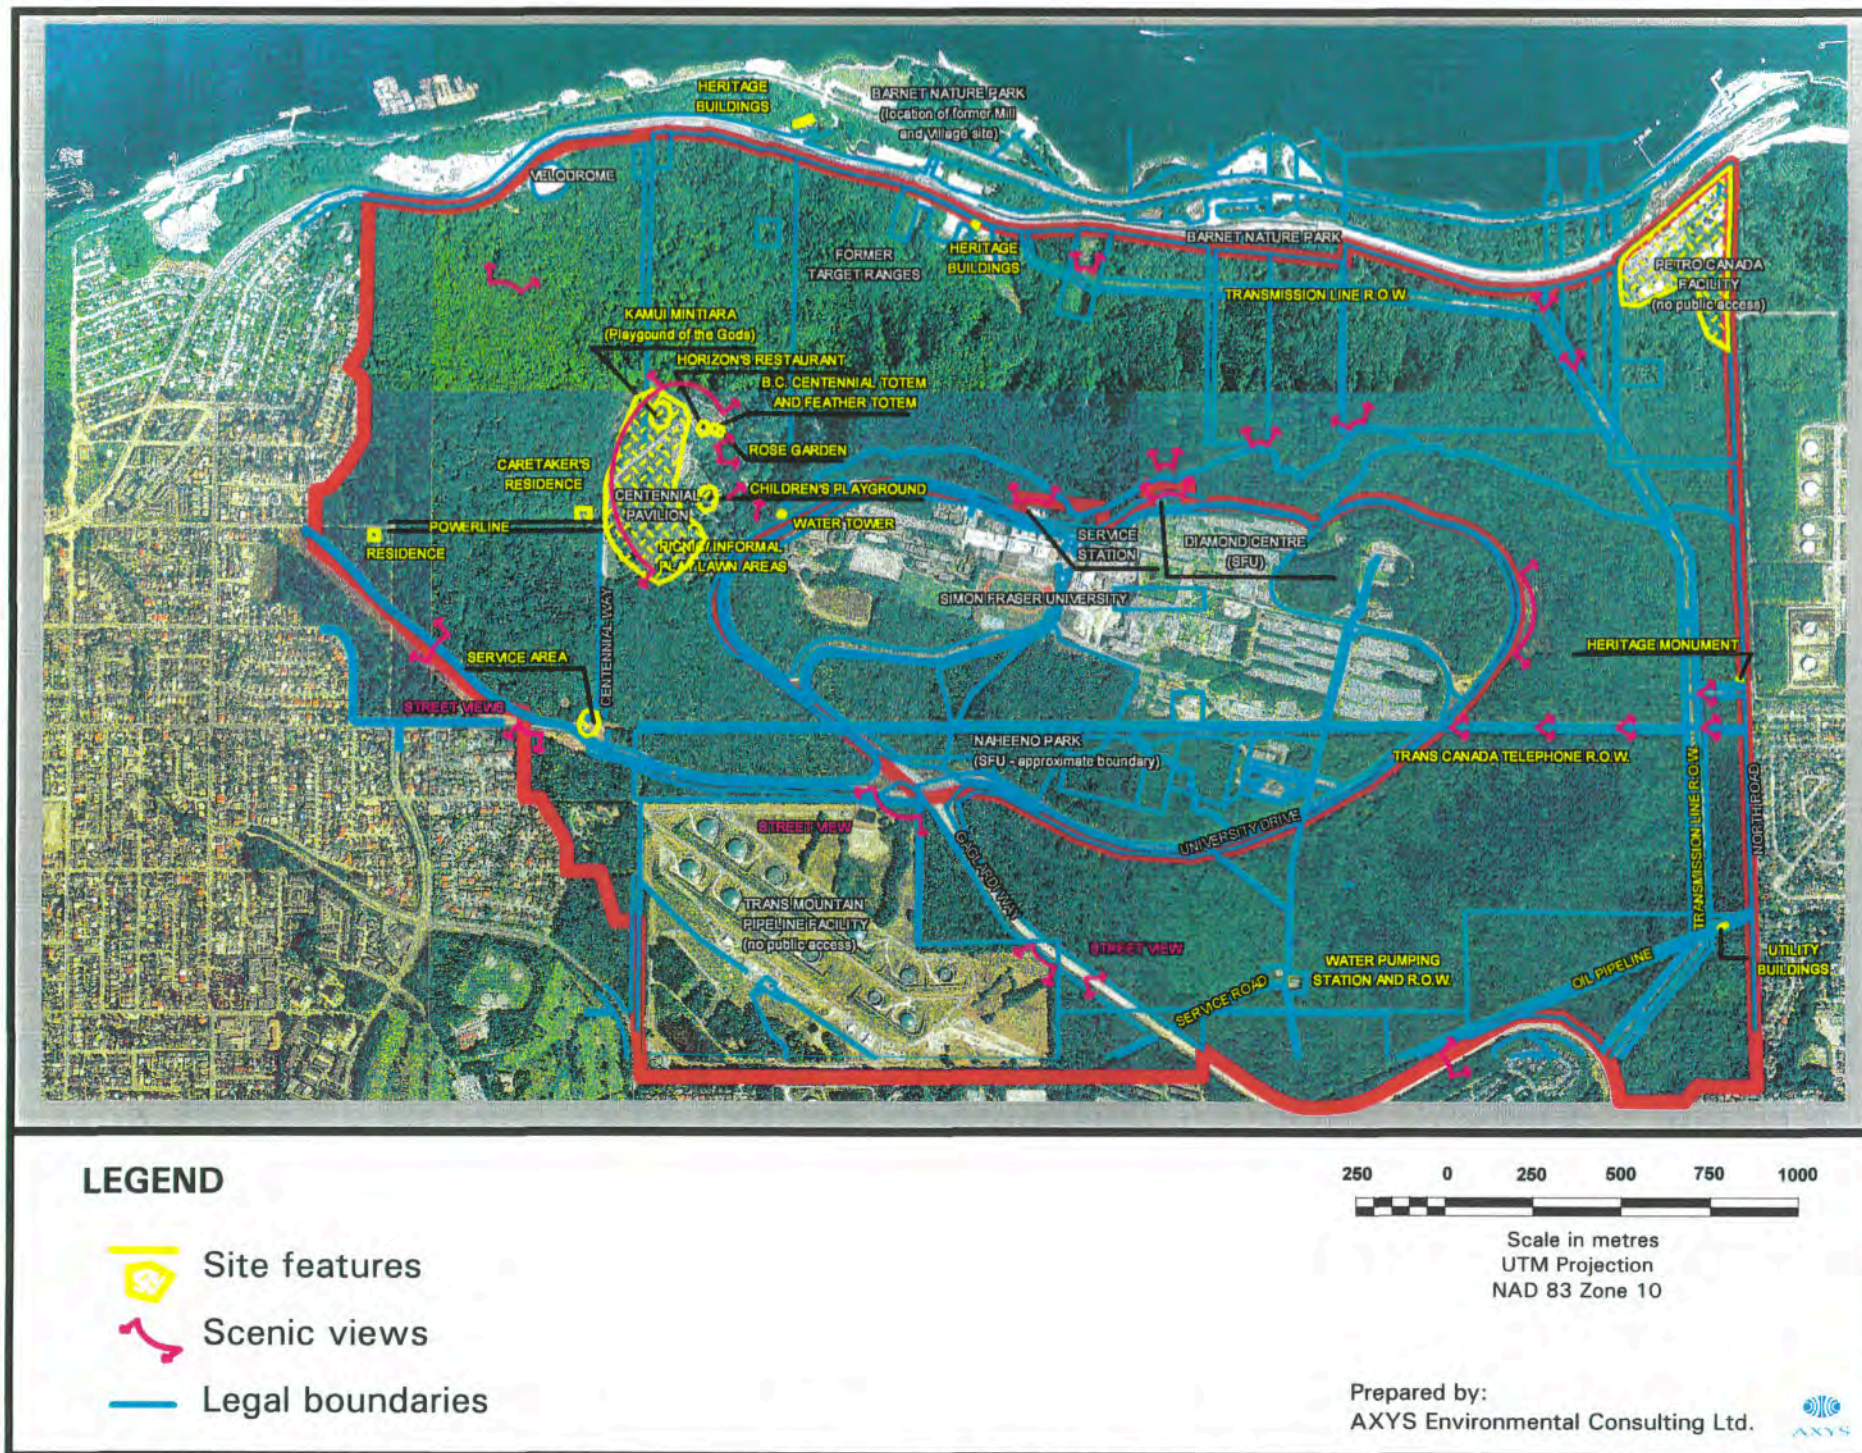
Figure 3-10: Visual Resources in the Burnaby Mountain Conservation Area

Figure 3-10 indicates the key view opportunities within the conservation area and the management zone for SFU. Burnaby Mountain offers dramatic views from a number of locations throughout the conservation area. Views are one of the key
